Specific Site Assessment for Blue Valley Power Station North and South Fly Ash Ponds and Bottom Ash Pond

Independence, Missouri

December 2010

Project Number: 092884

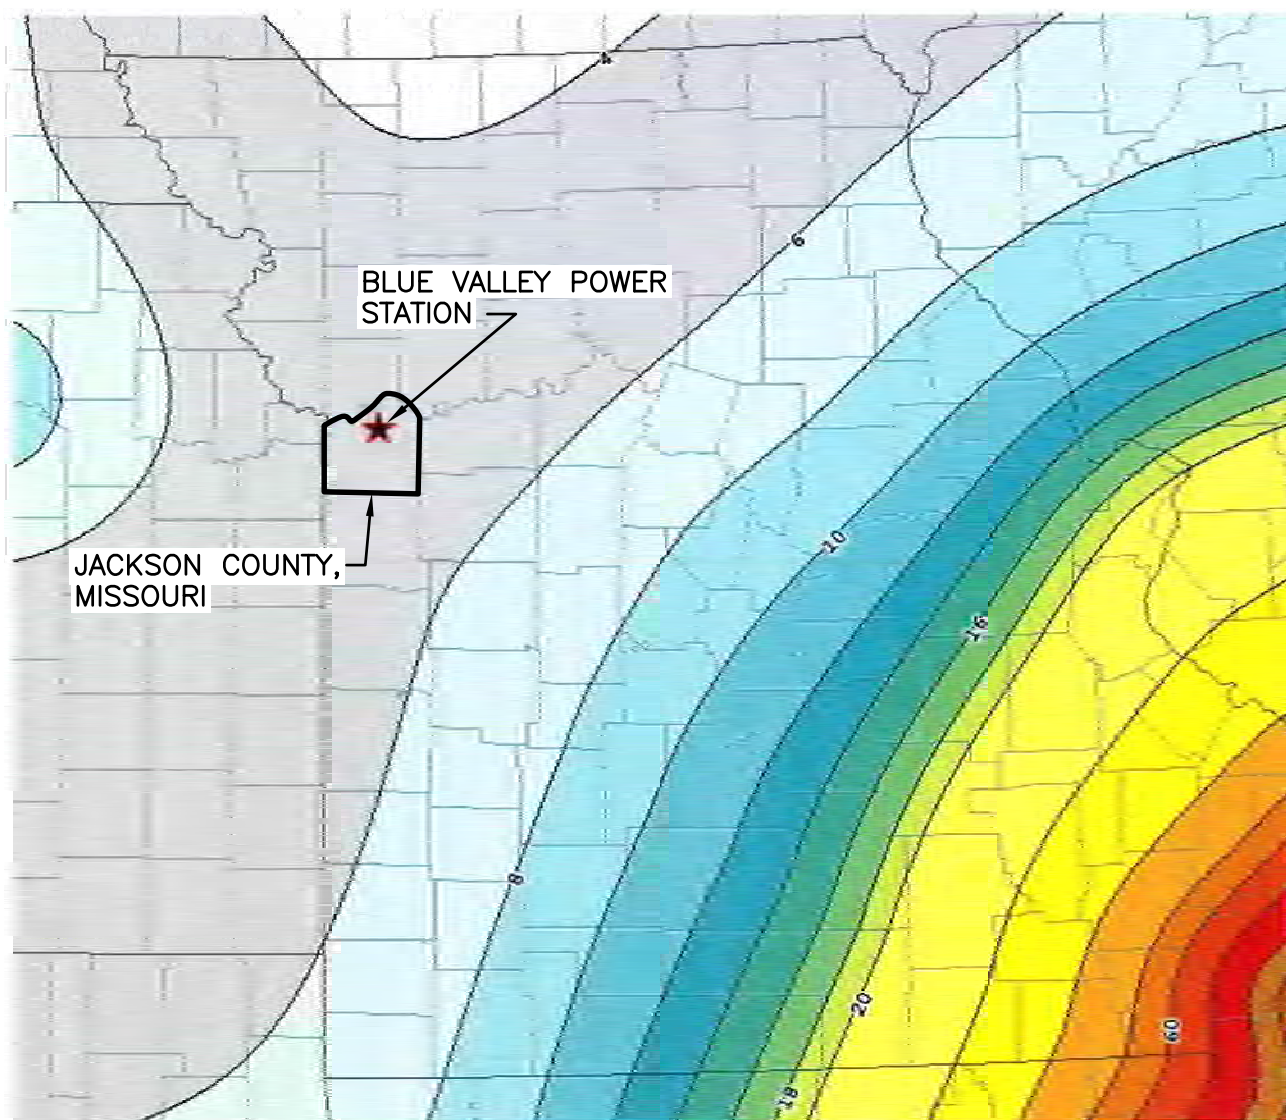
2008 U.S. GEOLOGIC SURVEY
(USGS) SEISMIC HAZARD MAP
OF MISSOURI

We are not aware of any seismic analyses that have been performed on the ash ponds at the Blue Valley Power Station. According to the 2008 U.S. Geological Survey (USGS) Seismic Hazard Map of Missouri (see Figure 2), the site has a regional probabilistic peak ground acceleration of 0.05326g with a 2 percent Probability of Exceedance within 50 years (recurrence interval of approximately 2,500 years).

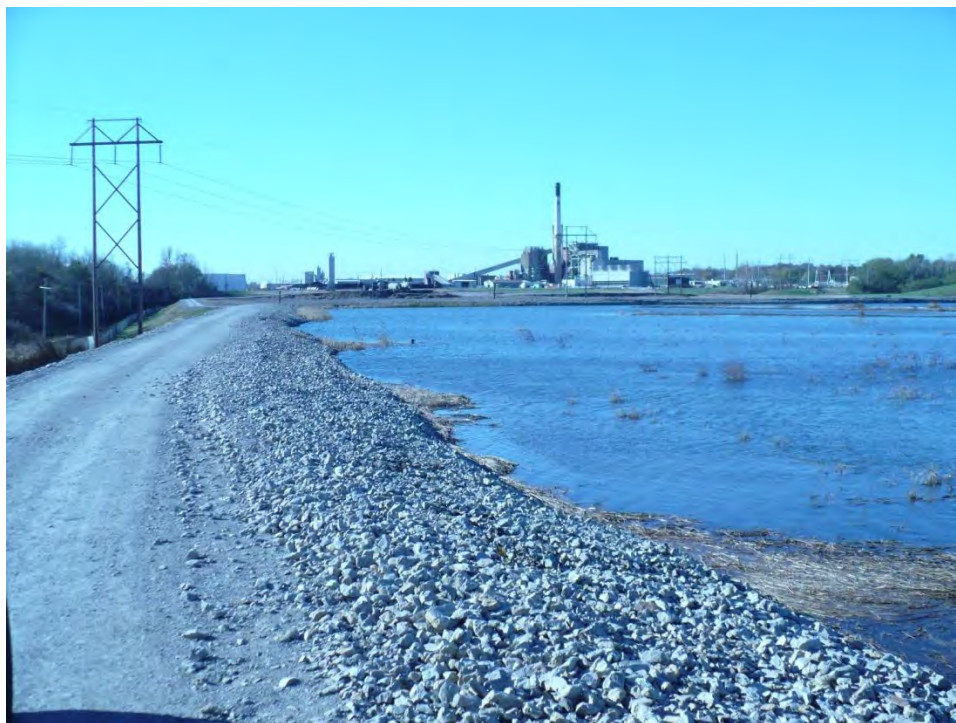
The crest of the dike at the North Fly Ash Pond appeared to be in good condition (see Photo 1). No signs of cracking, settlement, movement, erosion or deterioration were observed during the assessment. The crest appears to be well-drained and no standing water was observed. The dike crest surface is generally composed of gravel road base material that traverses the length of the dike for vehicle access.

Photo 1: Looking south along the east dike of the North Fly Ash Pond.

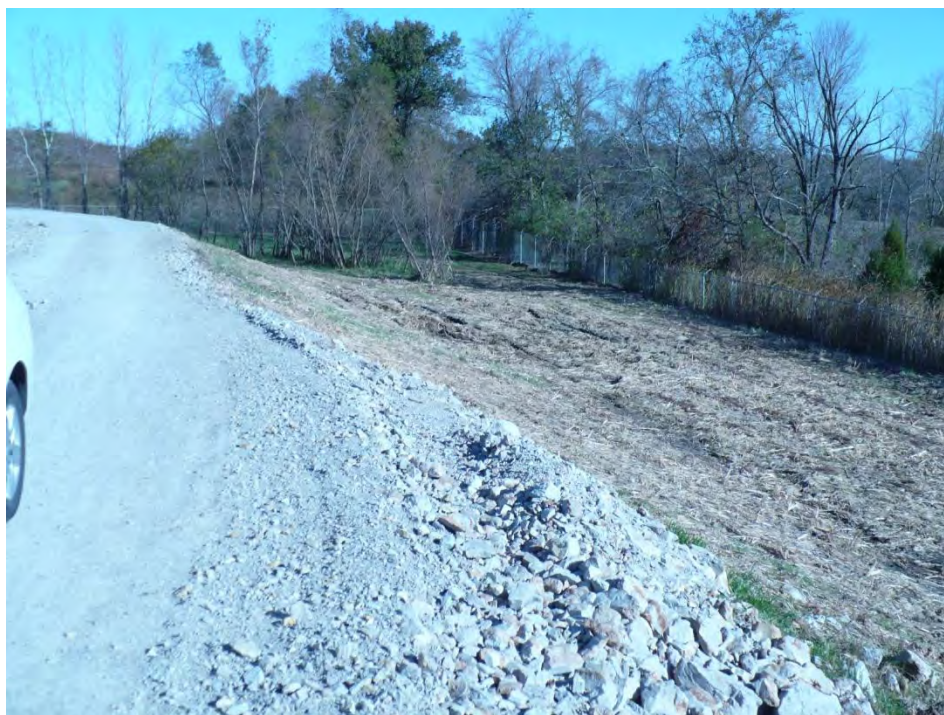
**Photo 2: The north east corner of the North Fly Ash Pond dike.
Note possible seepage occurring at dike toe.**

The dams and outlet works facilities associated with the impoundments at the Blue Valley Power Station were generally found to be in satisfactory condition. No visual signs of instability, erosion, movement were observed. However, there are wet areas within a storm water drainage ditch that runs along the toe of the east dike of the North Fly Ash Pond. The wet areas may be due to standing water within the drainage ditch, however they could also be seepage from the toe of the dike. Further evaluation should be conducted to determine the source of water in the wet areas.

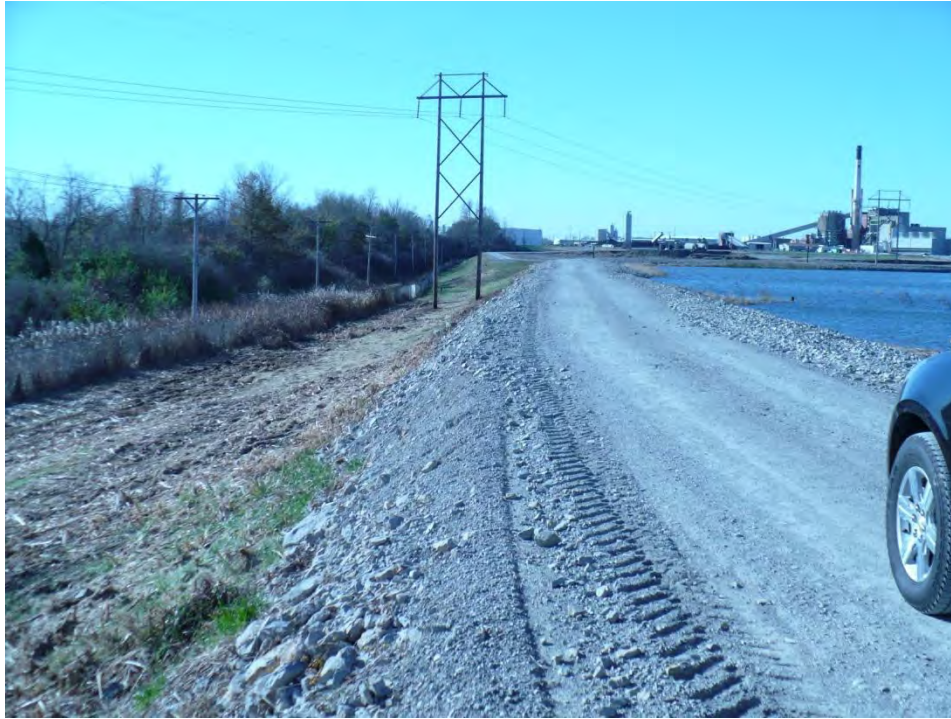
Photo 3: Looking south along the east dike of the North Fly Ash Pond.
Note possible seepage occurring at the dike toe.

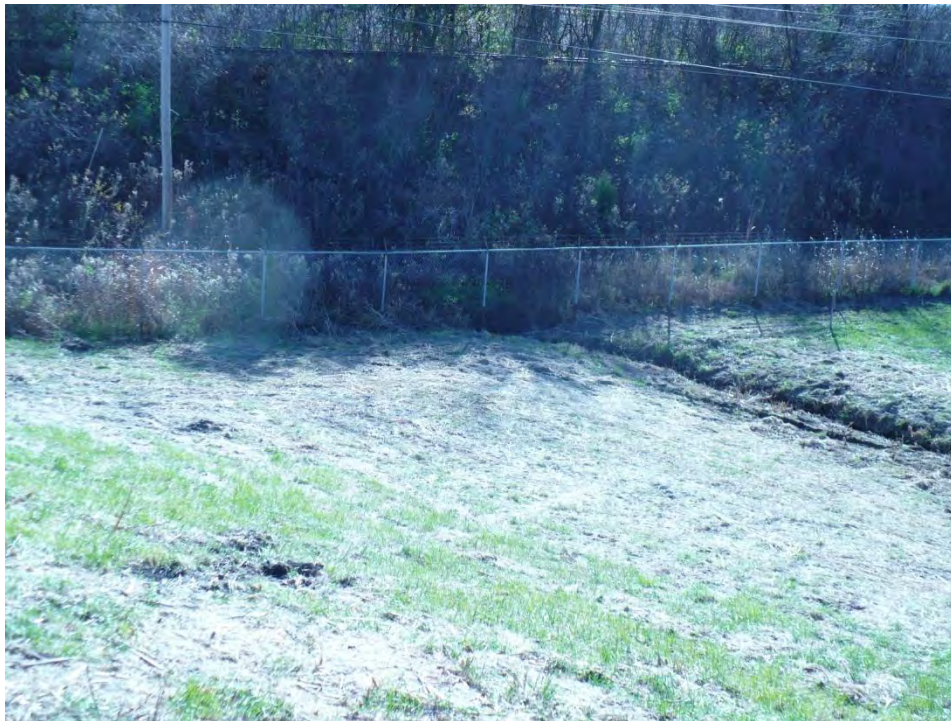
Photo 4: Looking east from the North Ash Pond dike at the abandoned railroad embankment. Site storm water is discharged to a 48 inch diameter culvert.

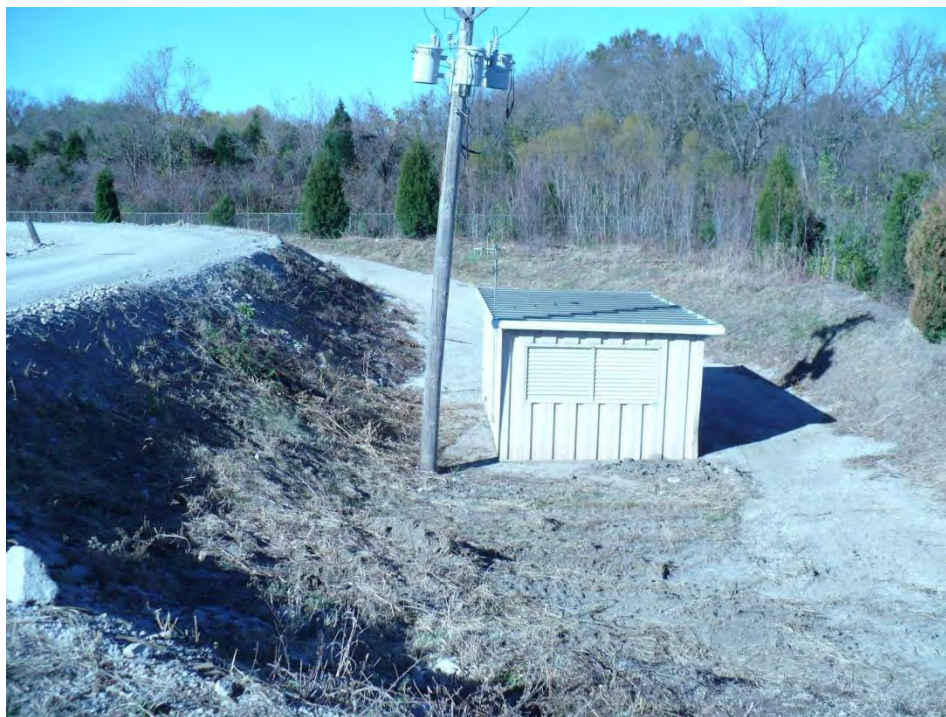
Photo 5: Return water pump house at north end of the Bottom Ash Pond.

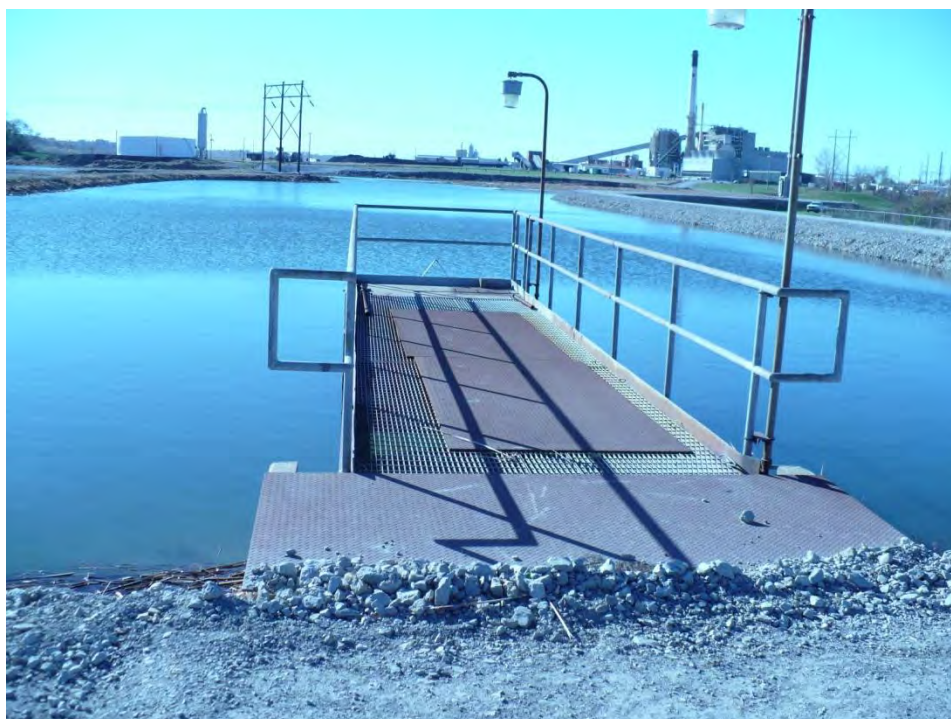
Photo 6: The Bottom Ash Intake Structure at the north end of the Bottom Ash Pond.

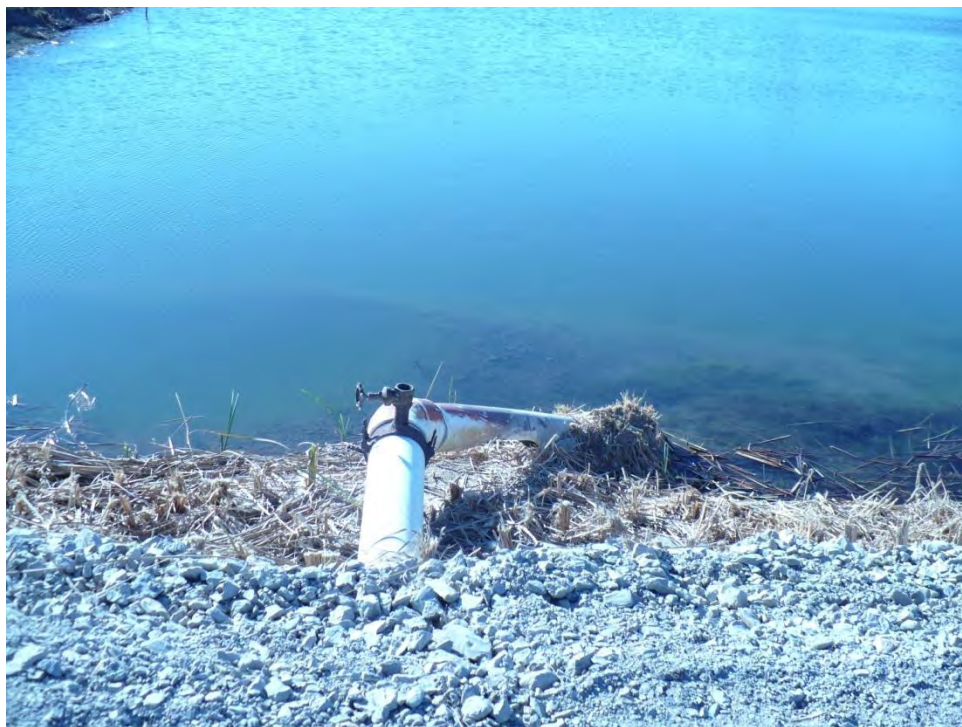
The outlet structure consists of an 8-inch diameter PVC pipe and appears to be in good condition. The invert for the overflow pipe is at elevation 768.0 feet. Currently, there is no active flow through the outlet structure.

Photo 7: The overflow outlet from the North Flyash Pond into the Bottom Ash Pond.

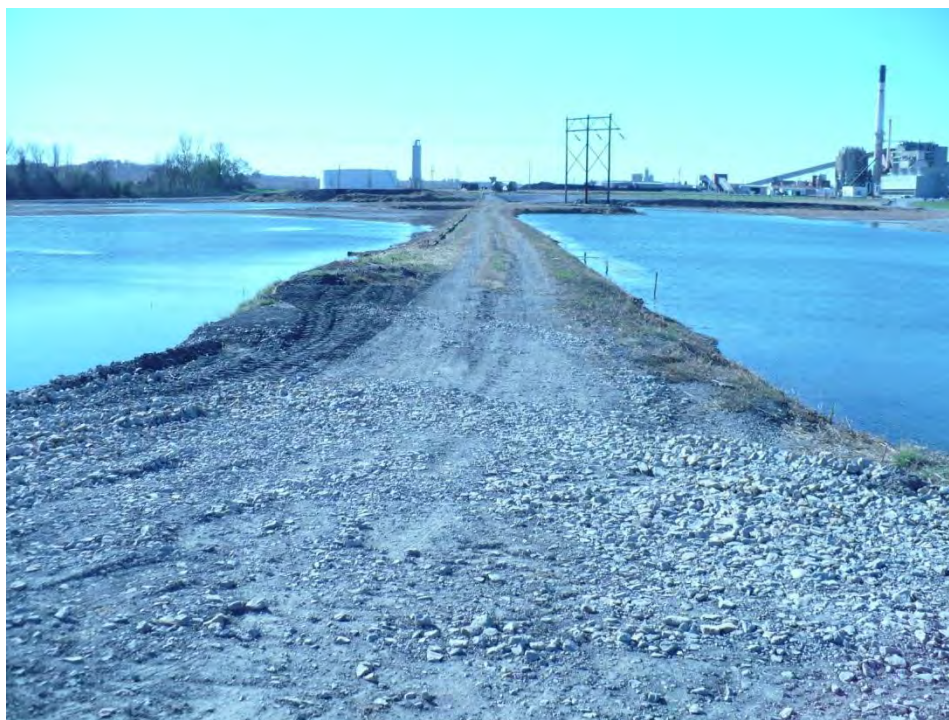
Photo 8: Looking south at the dike that separates the Bottom Ash Pond (right) from the South Fly Ash Pond (left).

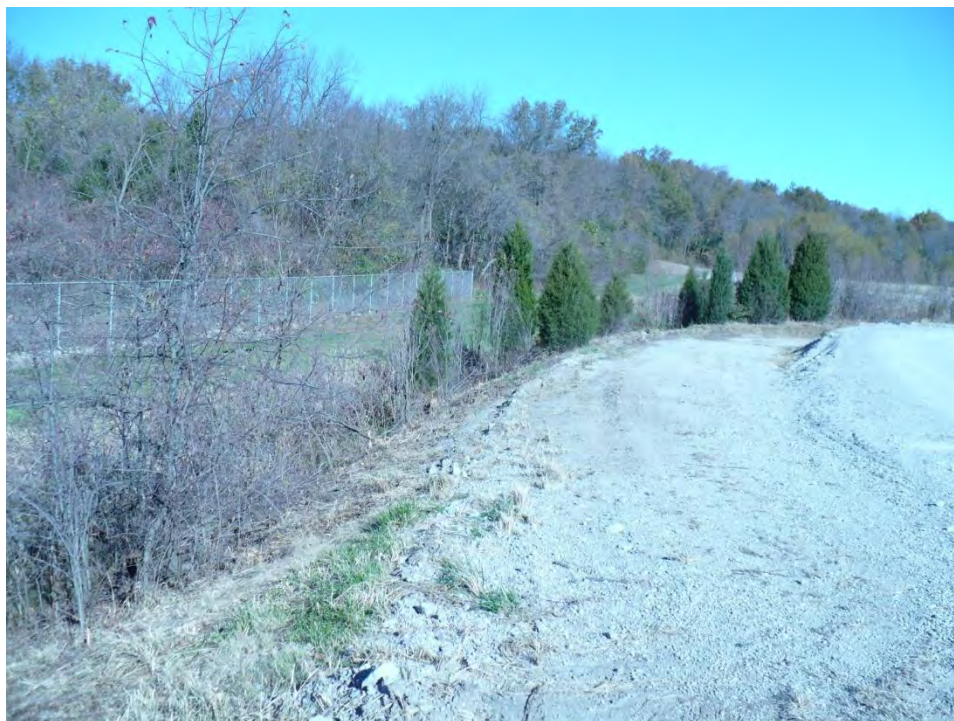
The downstream slopes of the dike at the Bottom Fly Ash Pond have well-established grass growth, which provides some erosion protection. No scarps, sloughs, depressions or other indications of slope instability or signs of erosion were observed during the inspection of the impoundment. A few small trees were noted to be growing on the slope of the pump house access road (see Photo 9). At this time, these trees do not present a concern, however consideration should be given to their removal.

Photo 9: Trees on slope of pump house access road slope at the northwest corner of the Bottom Ash Pond

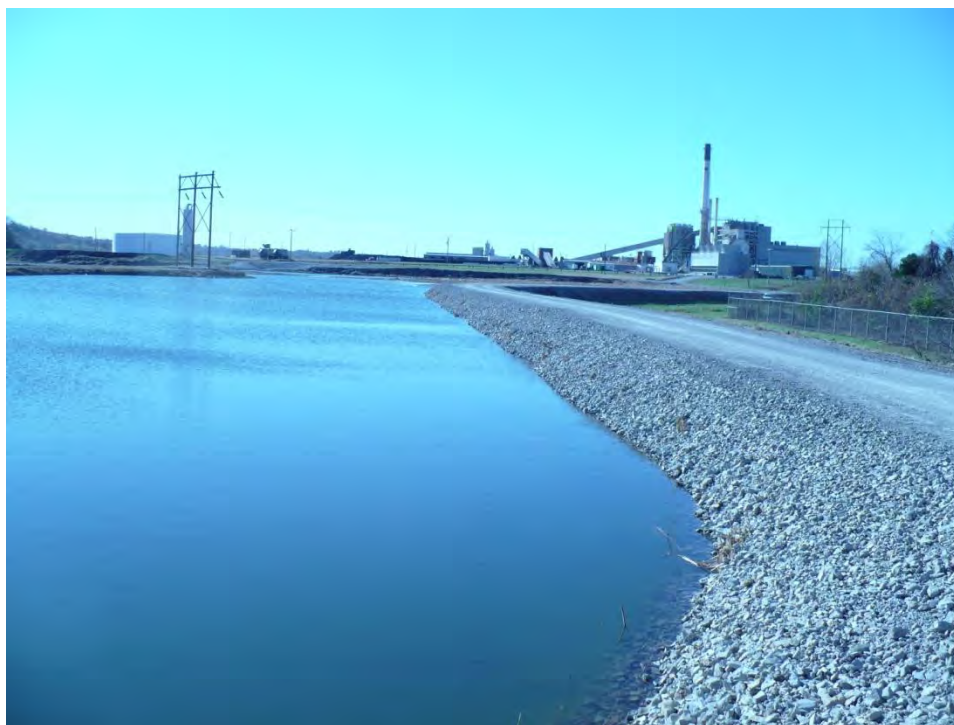
The crest of the dike at the Bottom Ash Pond appeared to be in good condition (see Photos 10 and 15). No signs of cracking, settlement, movement, erosion or deterioration were observed during the assessment. The crest appears to be well-drained and no standing water was observed. The dike crest surface is generally composed of gravel road base material that traverses the length of the dike for vehicle access.

Photo 10: Looking south at the Bottom Ash Pond west dike. Taken from the northwest corner of the Bottom Ash Pond.

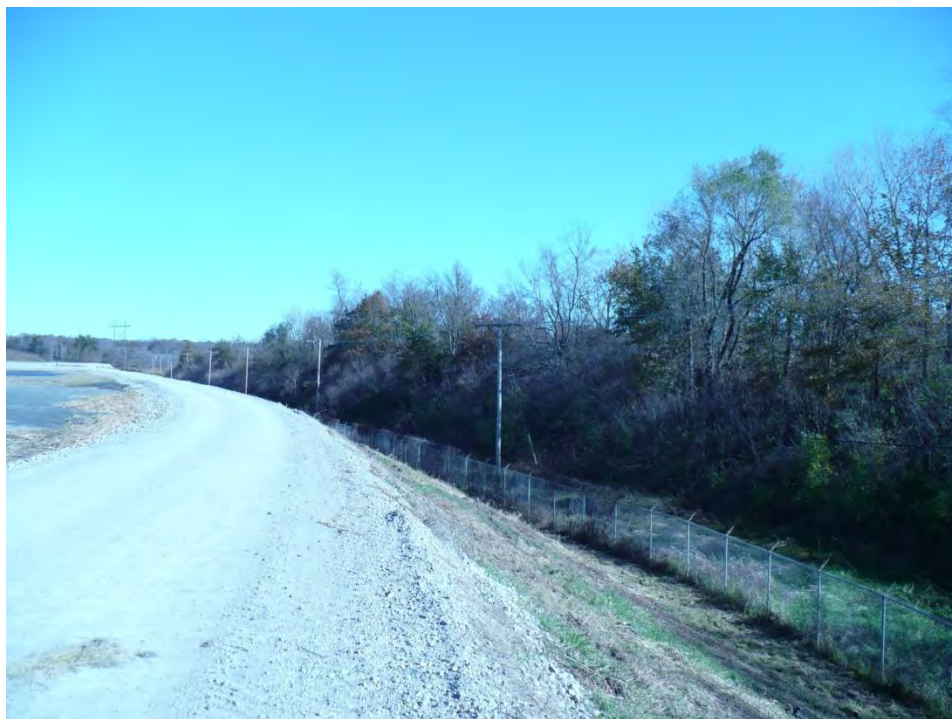
The downstream slopes of the dike at the South Fly Ash Pond have well-established grass growth, which provides some erosion protection (see Photo 11). No scarps, sloughs, depressions or other indications of slope instability or signs of erosion were observed during the inspection of the impoundment.

Photo 11: Looking north at the east dike of the South Fly Ash Pond.

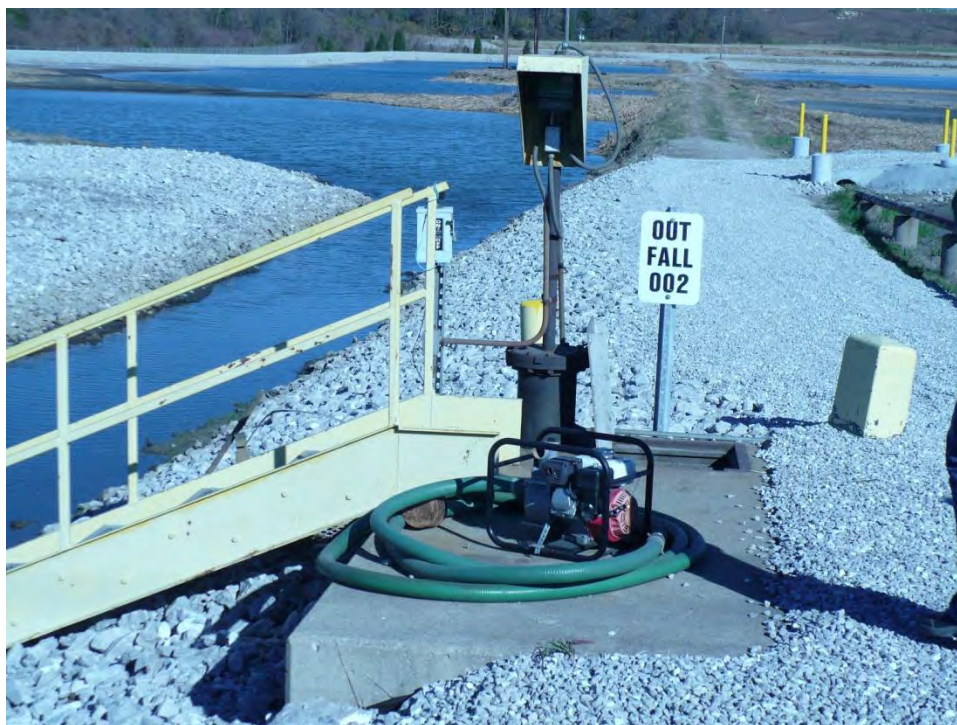
The outlet structure appears to be in good working condition and consists of a 12-inch diameter steel welded pipe discharging into a 12-foot long by 4-foot wide concrete vault that empties into the sanitary sewer system. There was a small amount of debris at the trash rack, but did not restrict flow into the outlet. The channel from the pond to the outlet was riprap and free flowing.

Photo 12: Outfall 002 and associated channel which is the outlet from the Bottom Ash Pond into the sanitary sewer system.

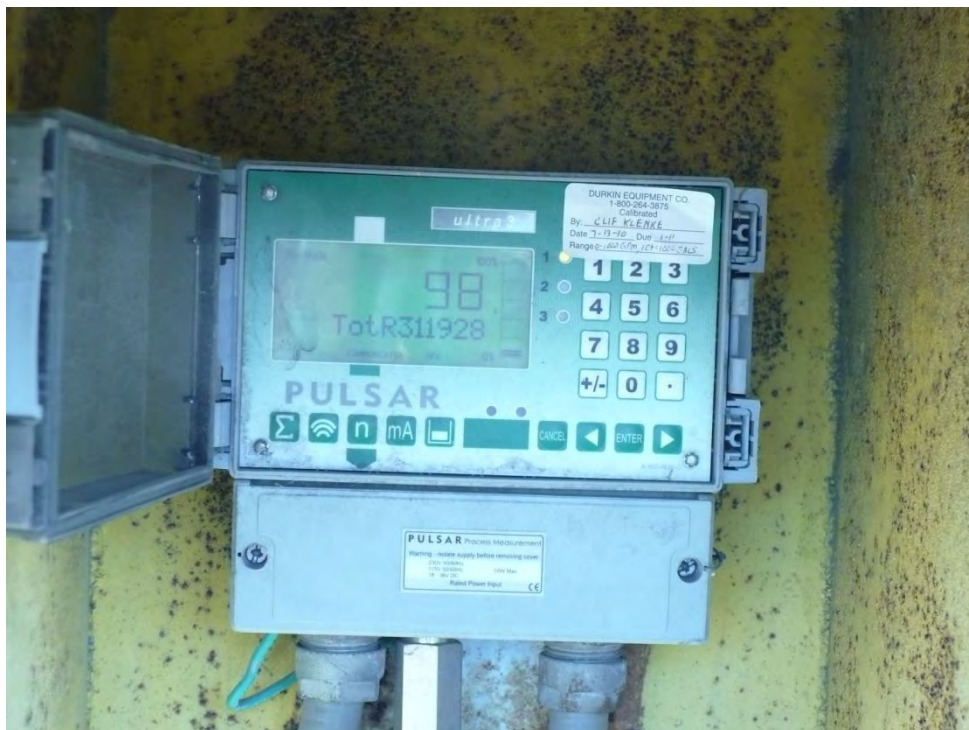
Photo 13: The flowmeter to monitor the discharge from the Bottom Ash Pond into the sanitary sewer system.

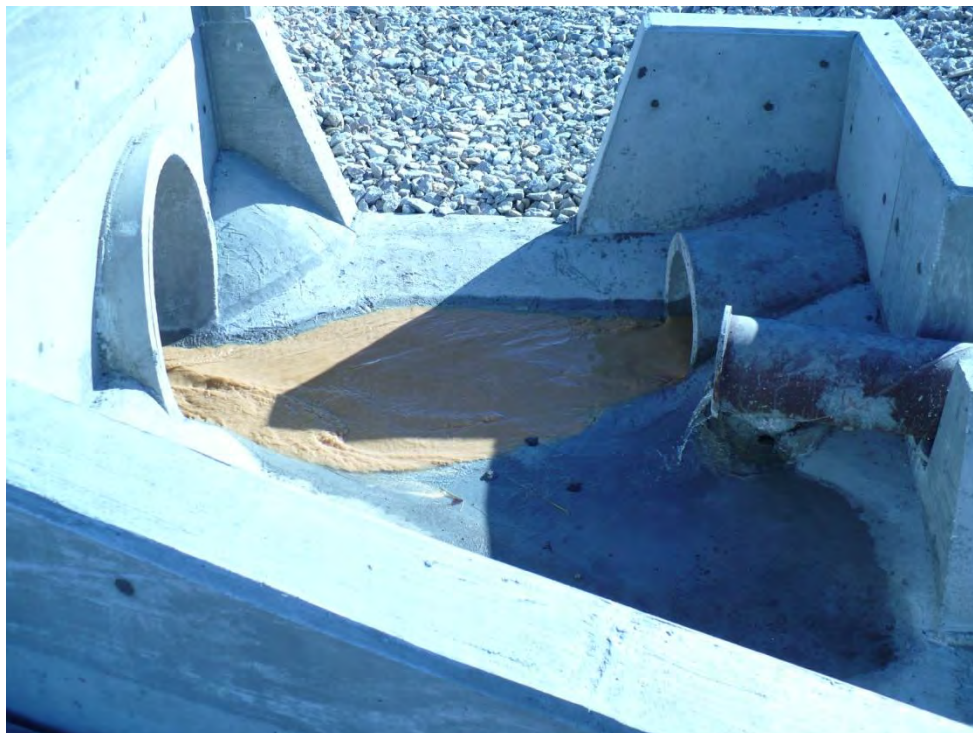
Photo 14: Inlet pipe to the Bottom Ash Pond.

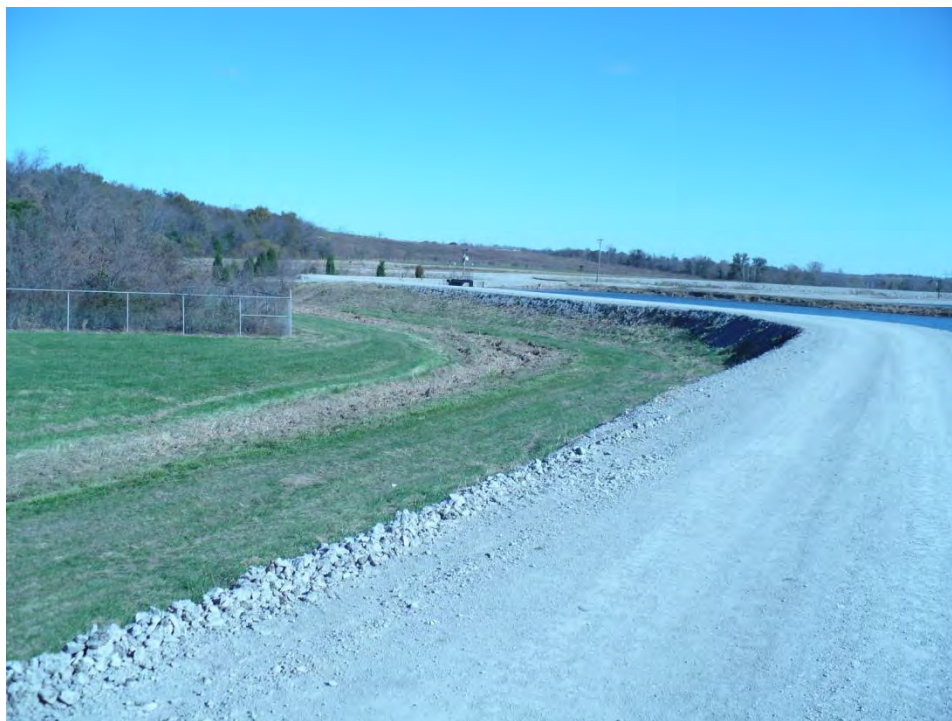
Photo 15: Looking north at the west dike of the Bottom Ash Pond.

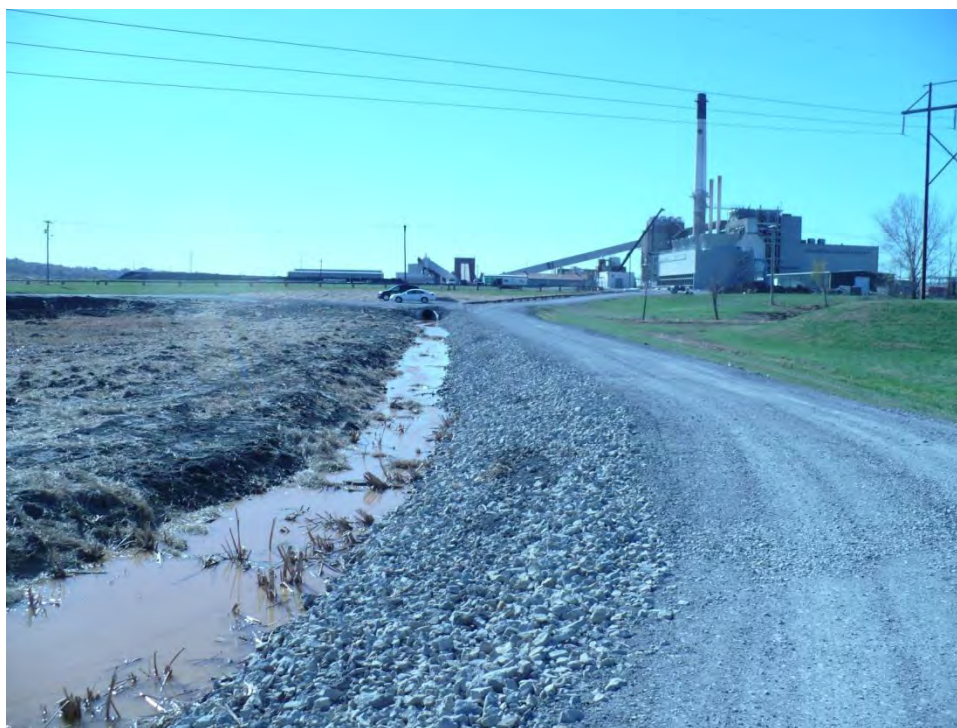
Photo 16: Looking south at the channel from the Bottom Ash Pond discharge into the pond.
